Appendix 6

BURNS AND MCBRIDE PROPERTY WILMINGTON, DELAWARE

SIRB ID: DE-0325

PCB Mass Loading
Burns and McBride Property
SIRB ID: DE-0325
Wilmington, Delaware

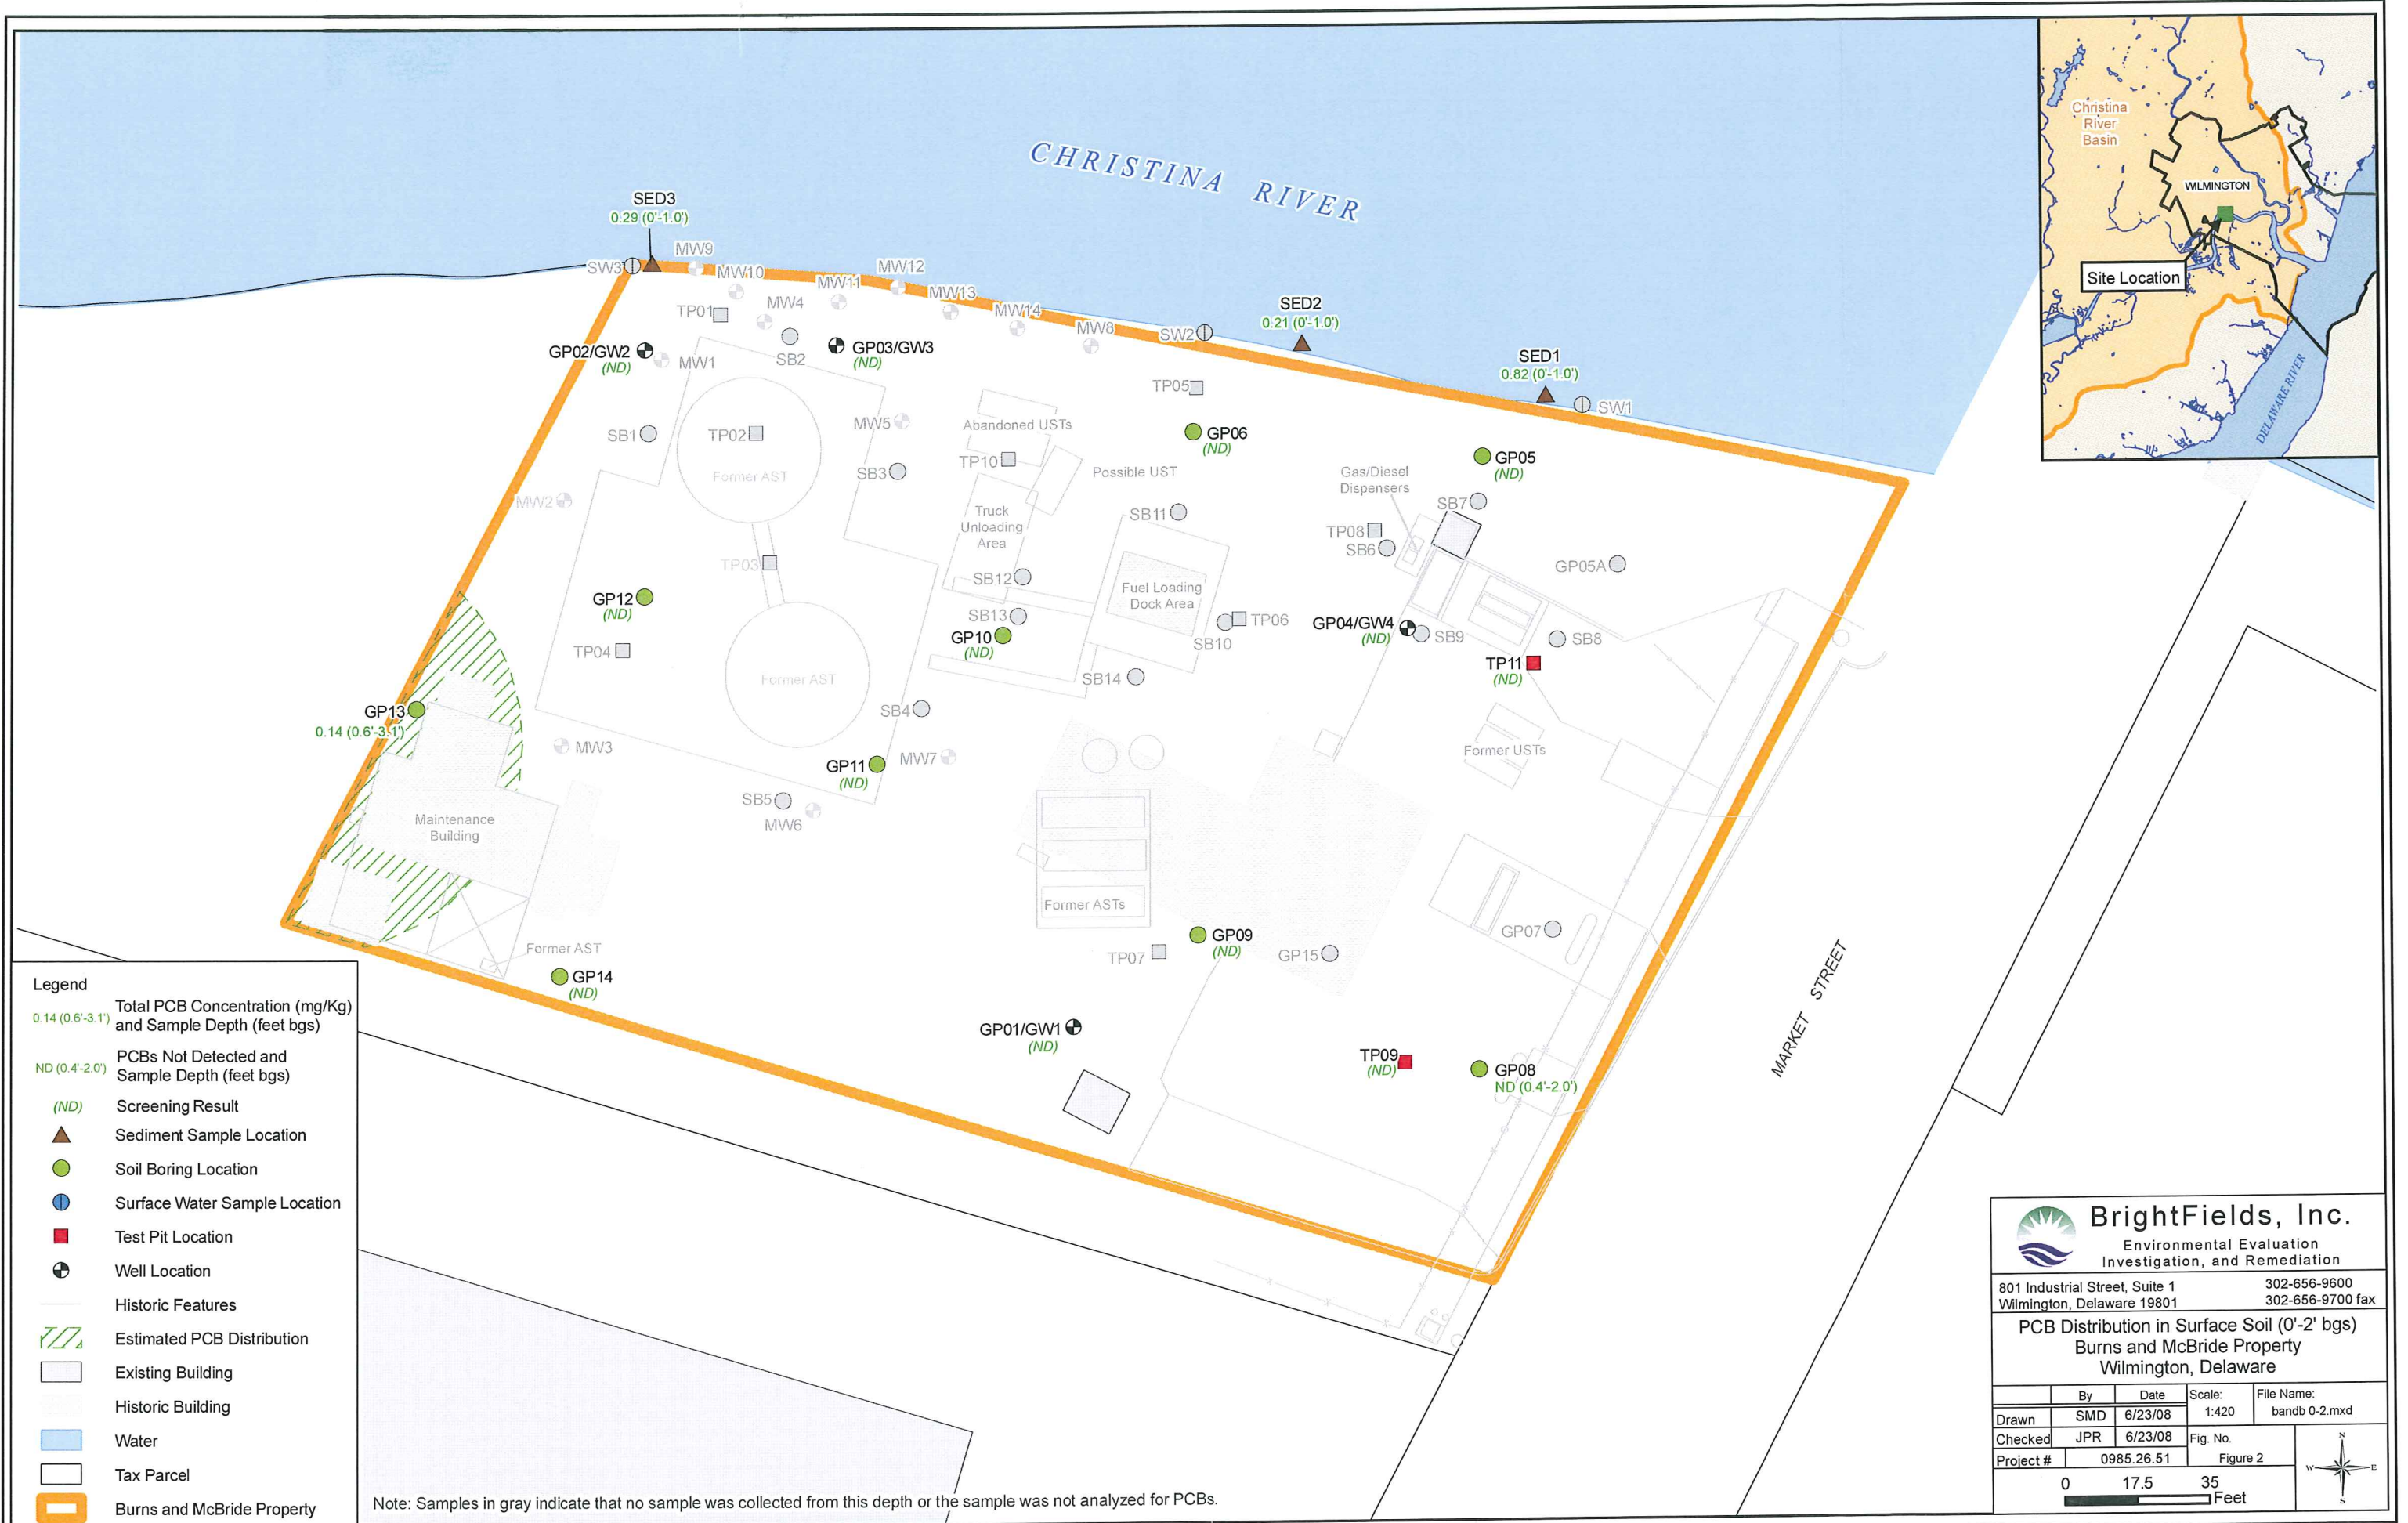
By	Date	Scale:	File Name:
Drawn	SMD	6/23/08	1:420	bandb 0-2.mxd
Checked	JPR	6/23/08	Fig. No.	
Project #	0985.26.51	Figure 2

PCB Distribution in Surface Soil (0'-2' bgs)
Burns and McBride Property
Wilmington, Delaware

Concentrations of PCBs on Site			
Sample Matrix	Corresponding Figure	Analytical Methods	Range of Total PCBs
Surface Soil	Figure 2	Method 8082	Not detected to 0.14 mg/kg
Subsurface Soil (unsaturated)	Figure 3	Method 8082	Not detected
Subsurface Soil (saturated)	Figure 4	Method 8082	Not detected
Groundwater	Figure 5	Method 8082	Not detected

Estimated surface soil area impacted by PCBs is 0.06 acres in the vicinity of GP13 (Figure 2). The total area of subsurface unsaturated soils impacted by PCBs is 0.19 acres in the vicinity of GP13. There were no reported concentrations of PCBs in the subsurface soils in contact with groundwater.

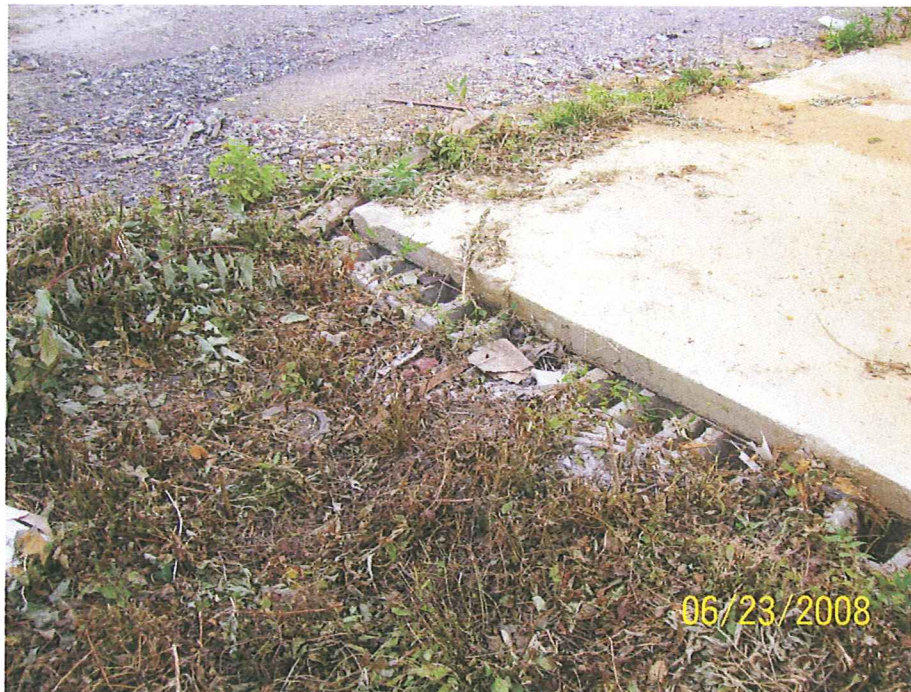
Approximate location of GP13; surface PCB concentrations detected at this location.

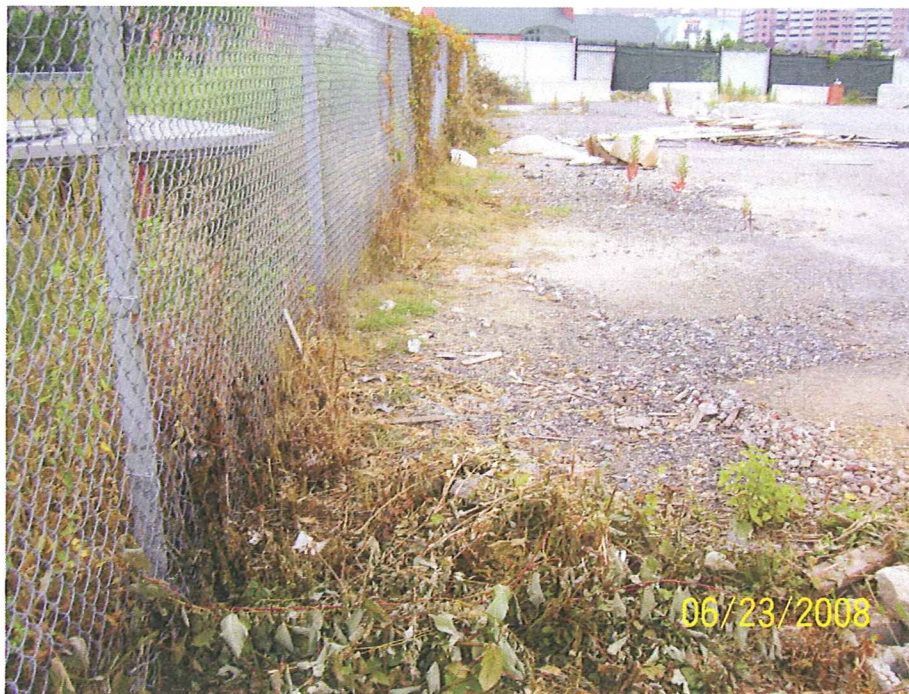
Overland flow pathway for GP13.

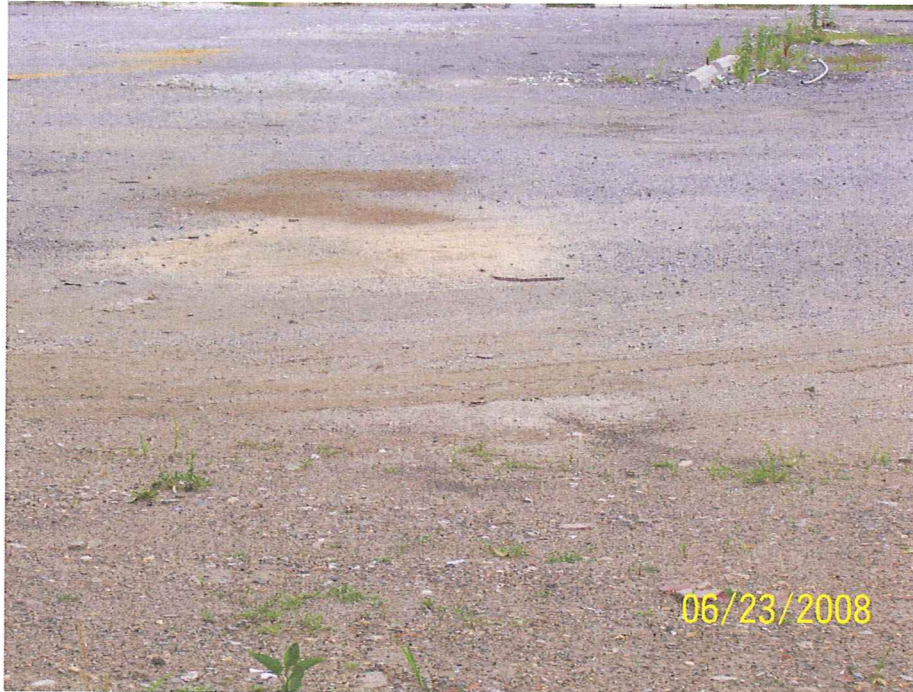
Stone mulch on-site, approximately 3 to 12 inches thick.

A site inspection was performed on June 23, 2008 to estimate the current site ground cover and canopy. The cover/management factor (C) assigned to the site and associated flow path is 0.0575, which corresponds to crushed stone mulch 4.5 inches thick. Photographs of the site ground cover and canopy are attached.

Currently the site has large Jersey barriers and sand bags to help prevent the off-site migration of soil. Crushed stone has been placed across the property (~ 3 to 12 inches thick) to allow for a temporary parking lot. Photographs of these sediment and erosion control techniques in use at the site are attached.
